# Effect of Stream Nutrients on Benthic Algal Overgrowth in Vatia Bay

**By: Gabrielle Langkilde**  
**Mentored by: Visa Vaivai-Tapusoa**

# Vatia Bay, American Samoa

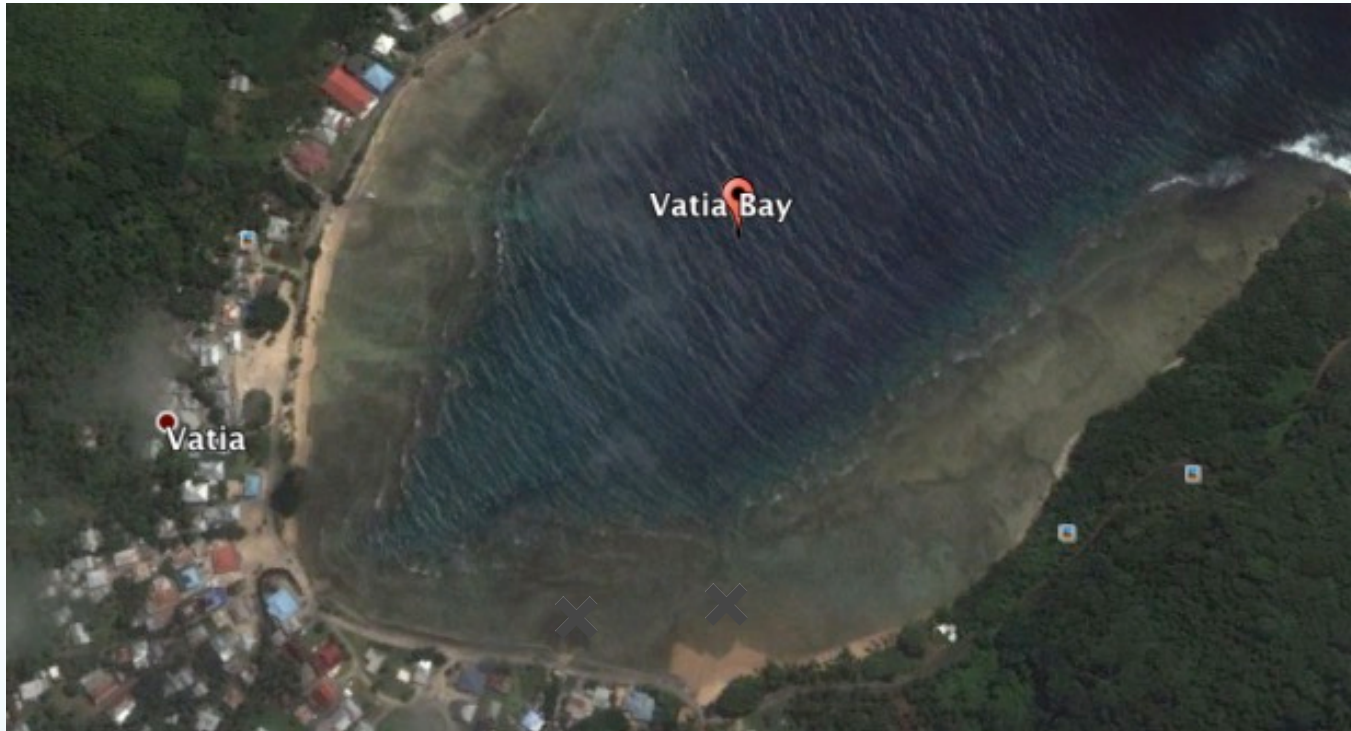
# Streams Feeding Vatia Bay

Vatia Bay is fed by several streams, that run down through the village of Vatia.

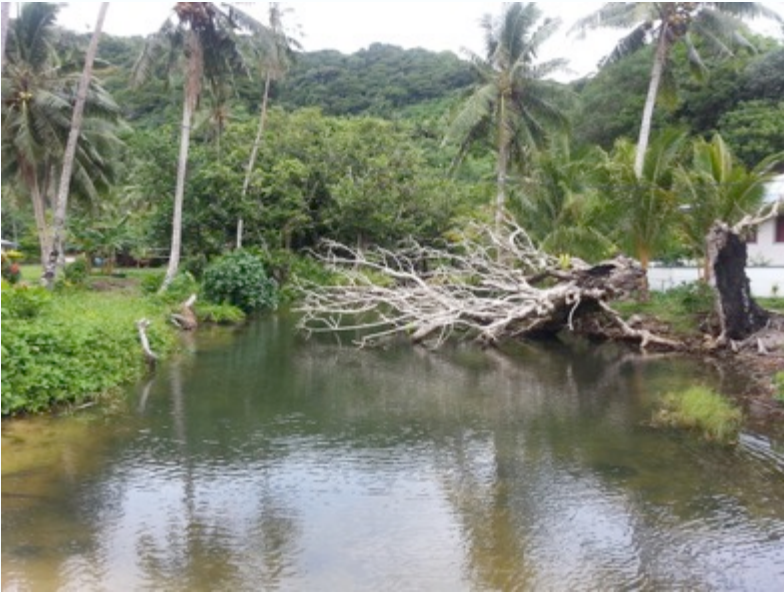
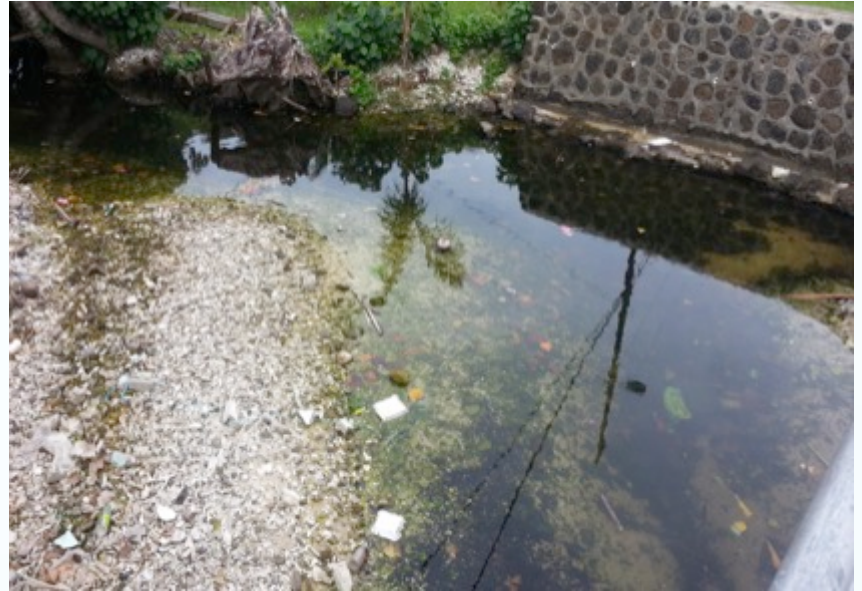
# Streams Feeding Vatia Bay

- Inventory and Monitoring Pacific Island Network (PACN ) water quality data on the streams feeding Vatia Bay indicates high nutrient levels.

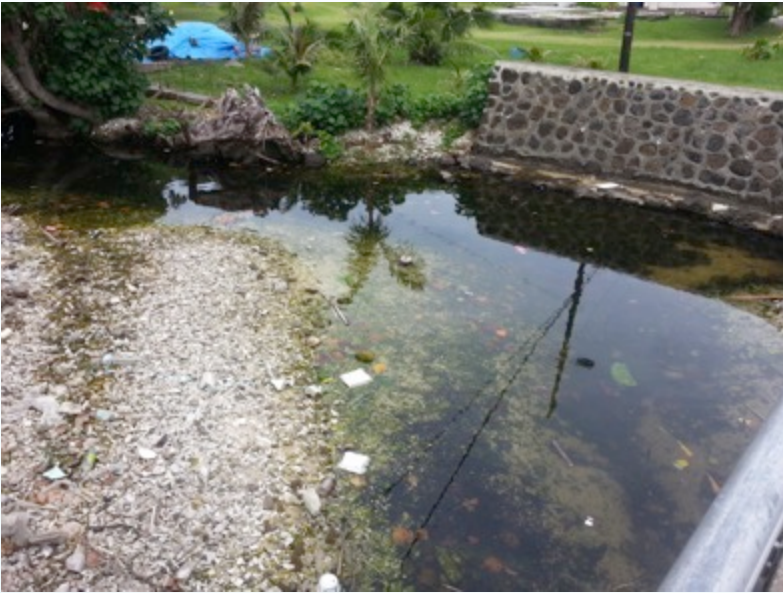
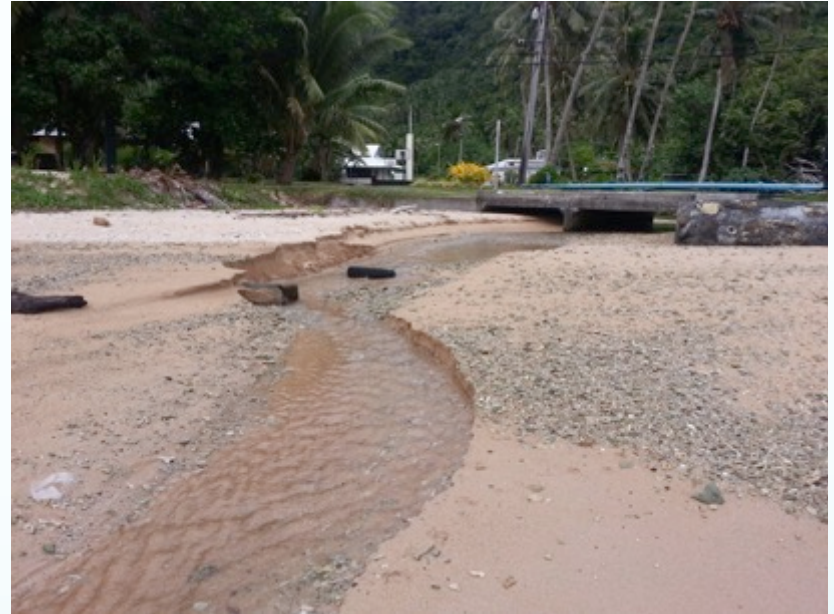
# Stream Mouths

Two streams feeding the Bay, shown as Stream 1 and Stream 2, were identified for this project.

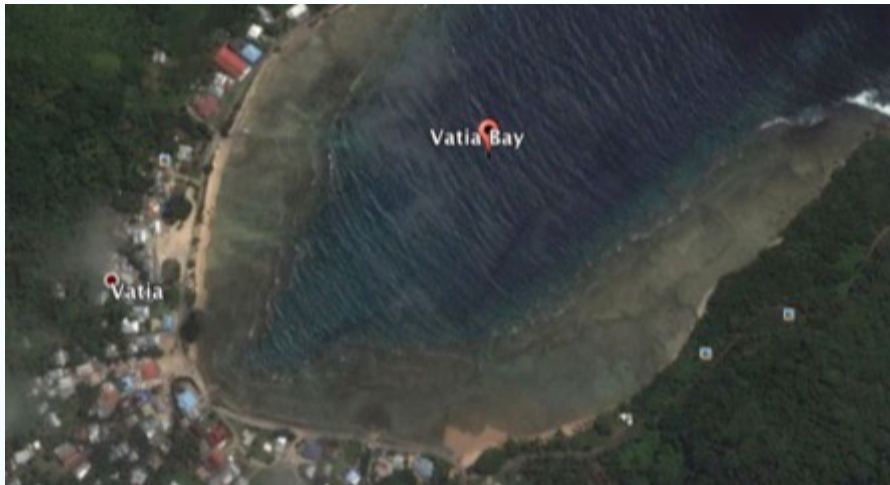
# Vatia Bay Nutrients (2015)

According to NOAA data collected from Vatia Bay, levels of nitrogen and phosphorus exceeded American Samoa Water Quality Standards (ASWQS).

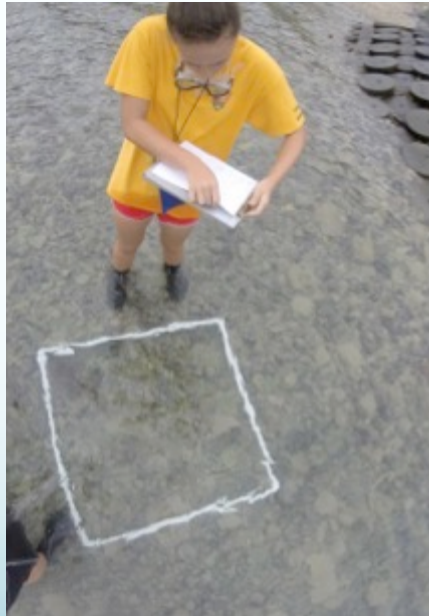
At each of these points, a 1m by 1m quadrat was laid on the ocean floor. Using an aqua-scope to view the material, the percentage of algae, coral, sand, and other material was estimated.

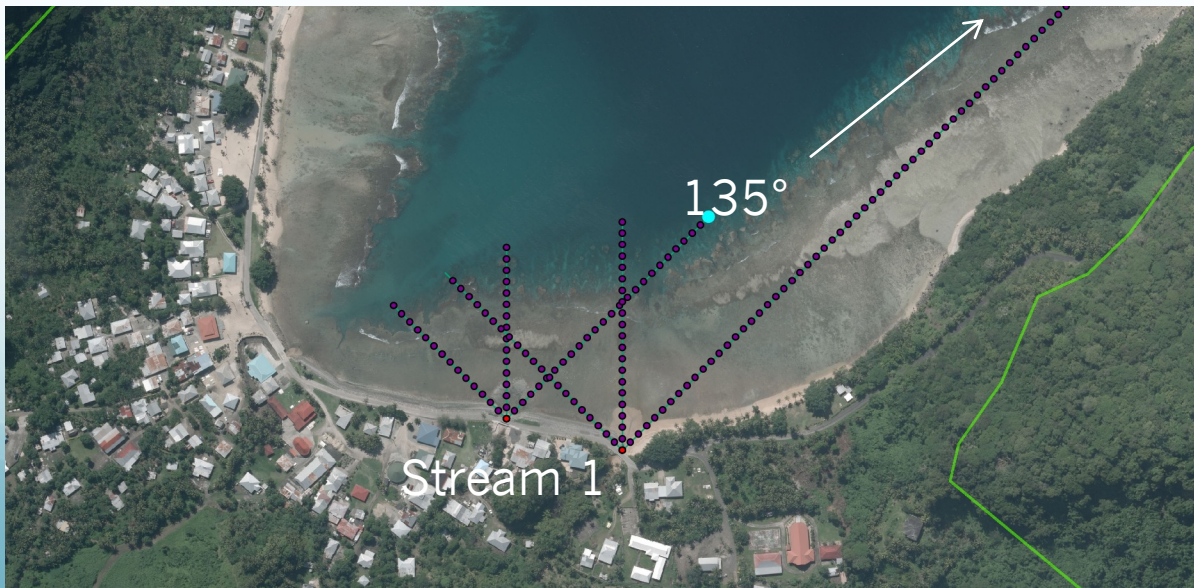
- The data collected was graphed to show the relationship between the amount of algae and coral vs. the distance from the stream.
- From the data, a linear line of best fit was graphed to show the general trend/slope of the data.

- **Percentage of Benthic Algal Cover vs. Distance from Stream**
  - Stream 1:
    1. 45 degree transect = -0.1179
    2. 90 degree transect = -0.1529
    3. 135 degree transect = -0.0607
  - Stream 2:
    1. 45 degree transect = -0.0167
    2. 90 degree transect = -0.0011
    3. 135 degree transect = -0.0077
- **The average slope of the six transects = -0.0595**

- **Percentage of Coral vs. Distance from Stream**
  - Stream 1:
    1. 45 degree transect = 0.1339
    2. 90 degree transect = 0.1814
    3. 135 degree transect = 0.0905
  - Stream 2:
    1. 45 degree transect = 0.0800
    2. 90 degree transect = 0.0464
    3. 135 degree transect = 0.0038
- **The average slope of the six transects  $\approx$  0.0893**
